## **TERMATRAC TEST REPORT** **SUPPLEMENT TO TIMBER PEST REPORT**

<b>Tests were carried out by:</b>	Smart Cookie
<b>Date:</b>	July 17, 2014
<b>Timber Pest Report Number:</b>	1
<b>Report for building at:</b>	14/65 Christensen Rd, Stapylton
<b>Report requested by:</b>	Ron Burgundy

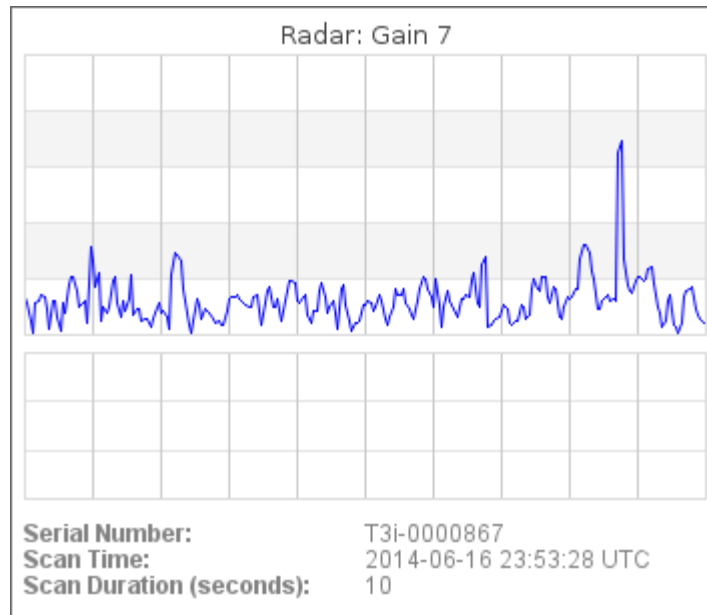
## 1.1 Radar Scan

**Damage Visible:** Yes

Privacy door jamb

Coptotermes Spp. located within garage molding timbers (skirtings, architraves, door jamb). The damage is wide spread and an entrance point has been located on the northern wall. In this instance the Termites have entered over the slab edge and Kordon sheeting which was bridged by a cardboard storage box.

*\*Note: At the time of the Termtac testing it was impossible to confirm insect activity. It is advisable to reinspect and test this area at a different time of day or a later date or perform a more invasive inspection.*

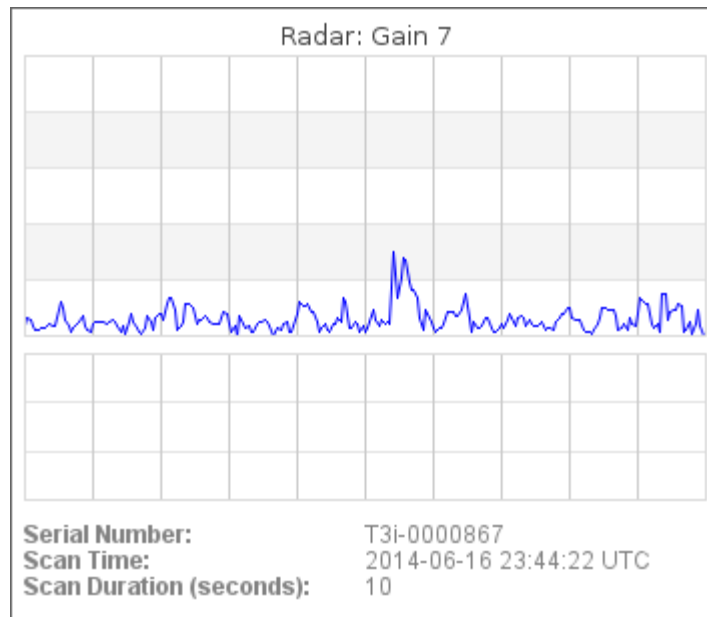
## 1.2 Radar Scan

**Scan Location:** Interior/Garage  
**Termatrac device was:** On a solid platform  
**Termatrac device position:** Flush against surface  
**Damage Visible:** Yes

Privacy door eastern jamb

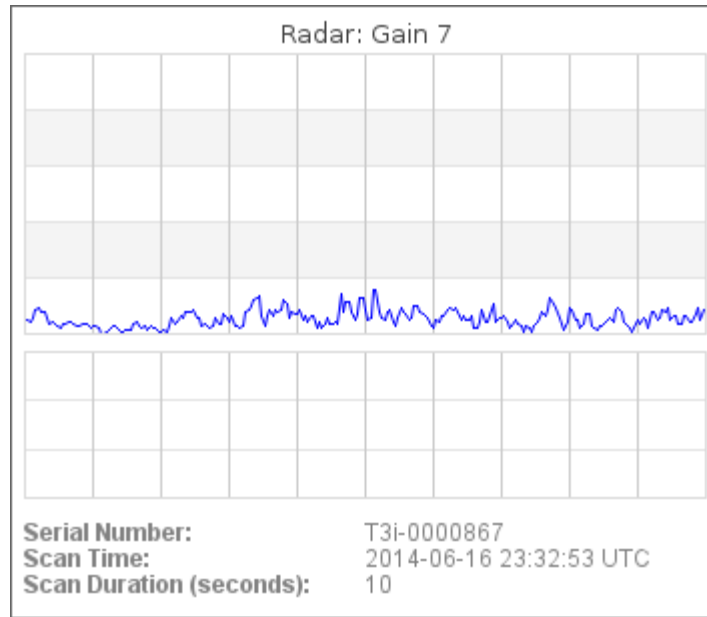
### 1.3 Radar Scan

**Scan Location:** Interior/Garage  
**Termatrac device was:** On a solid platform  
**Termatrac device position:** Flush against surface  
**Damage Visible:** Yes

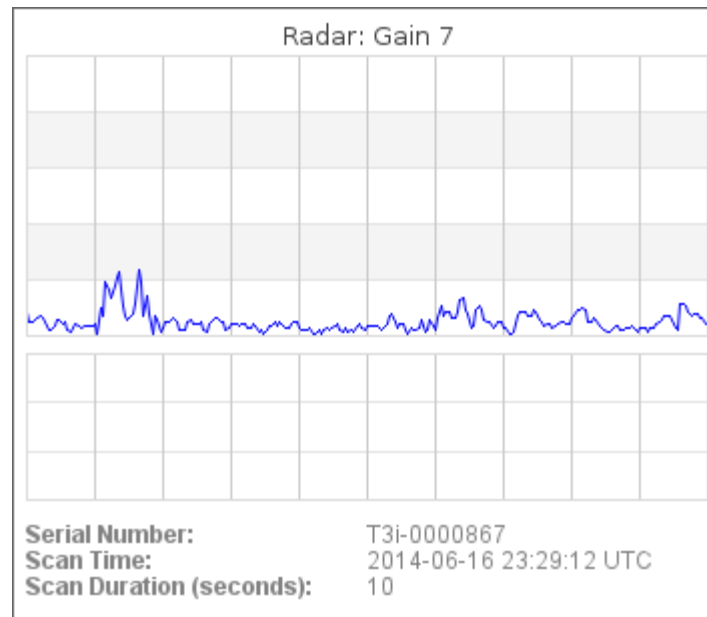
## 1.4 Radar Scan

**Scan Location:** Interior/Garage  
**Termtac device was:** On a solid platform  
**Termtac device position:** Flush against surface  
**Damage Visible:** Yes
